UTAH STATE CAPITOL ARCHITECTURE: EXTERIOR SURVEY REPORT

ELEVATION LOCATION: ROOF

Survey Date: 4/26/00

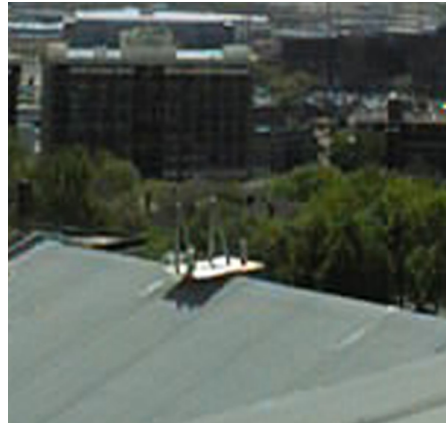
Code: EX-000

Description: Intrusive Element

Location: South elevation of roof

Condition: INT

Intrusive, non-original, non-essential element

Comments: Small metal platform W/ attachments on top of roof above pediment.

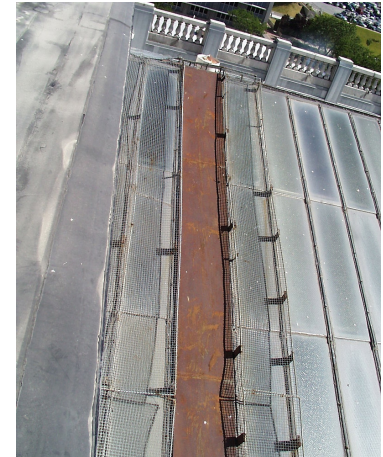
Code: EX-000

Description: Intrusive Element

Condition: NO

Non-original, incompatible but essential elements

Comments: wire net protects skylight from ice fallen from dome

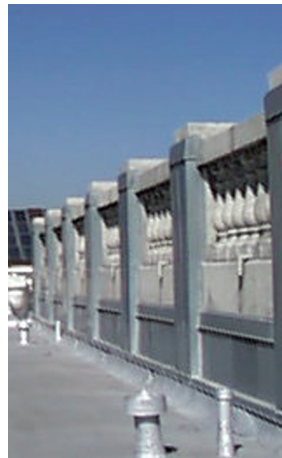
Code: EX-017

Description: Balustrade baluster

Location: typical

Condition: EX

Exfoliated or spalled surface

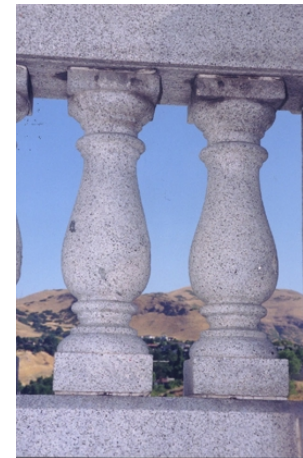
Code: EX-018

Description: Balustrade railing

Location: along roof top

Condition: J

Mortar joint with missing or loose mortar

Comments: Some joints on the top of the balustrade railing cap are exposed and/or missing (middle and next to newel posts).

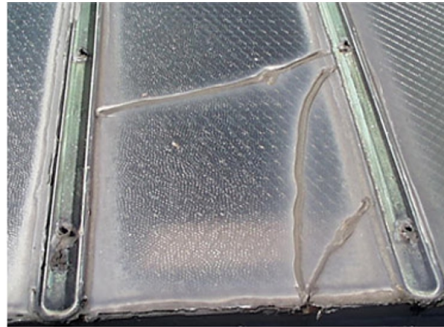
Code: EX-022**Description:** Skylight roof**Location:** Typical on all roof skylights**Grid:** typical**Condition:** GL

Glass cracked, broken or non-matching

Comments: breaks in glass- most filled with silicon caulking.

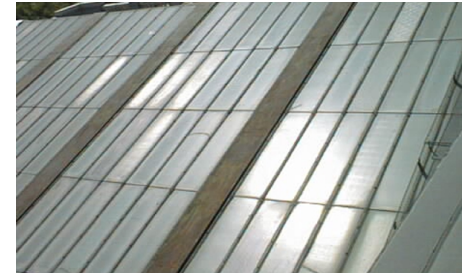
**Code:** EX-022**Description:** Skylight roof**Location:** Typical on all roof skylights**Grid:****Condition:** GL

Glass cracked, broken or non-matching

Comments: Glass non-matching- 60% of one kind 40% of another.

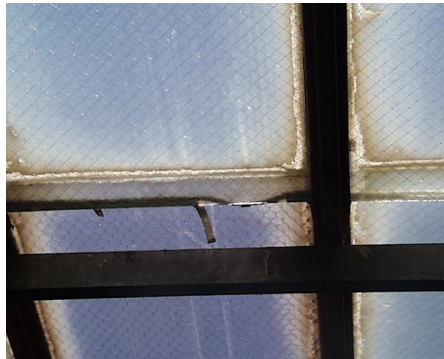
**Code:** EX-022**Description:** Skylight roof**Location:****Grid:****Condition:** CK

Caulking missing, damaged or non-matching

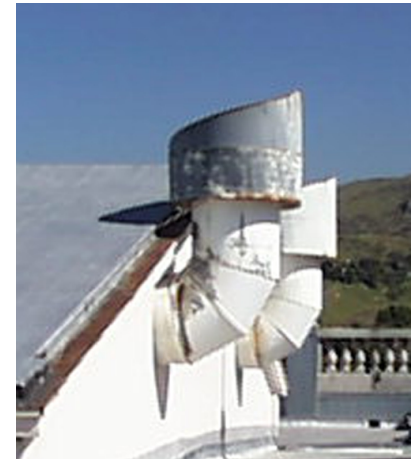
**Code:** EX-076**Description:** Vent stack**Location:** Typical**Grid:****Condition:** MT

Metal damage

Comments: Original vent stacks near skylight metal rusted on covers and brackets- generally in bad condition.

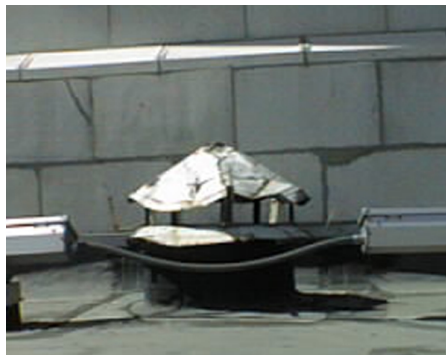
Code: EX-076

Description: Vent stack

Location: Typical on roof level above main roof around dome.

Condition: MT

Metal damage

Comments: metal covers dented from falling ice and rusted
